## Rescue mission for an Austin-Healey that appeared to be out for the count

When the Austin-Healey 100-6 BN4 was involved in a crash, its owner was deeply distressed. The damage was considerable — but it didn't signal the end of the road. A bodyshop based in Düsseldorf took on the legendary roadster, rebuilt it and gave it a new shine.

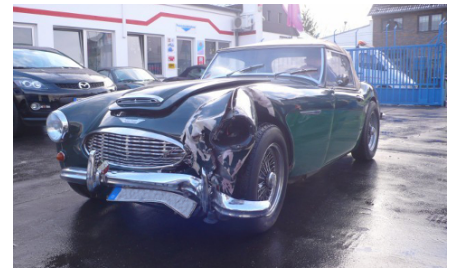
Beumer and his employees took stock of the damaged components. The list was long: The front headlights had been knocked out, the left-hand wing was warped and cracked, the head fairing was severely deformed, the bumper was twisted and the side member was bent. There looked to be a lot of work ahead.

*The rear-end collision caused significant damage to the front left-hand side of the Austin-Healey 100-6 BN4.*

The next step was to find spare parts. "There are specialist companies that still stock original parts for English vintage cars", explains Beumer. He was able to find some of the parts, but not all of them: "We were unable to get hold of a Healey aluminium head fairing. We had this part reproduced by a blacksmith shop in England". While this was being done, Beumer reconditioned the drive technology. The Healey was fitted with a new gearbox and disc brakes instead of drum brakes. The aim was to make improvements that were sensible but did not change the car's appearance. Beumer remarks: "From the outside, the car still looks like an original".

Beumer employed tried-and-tested technology during the painting process too: He wanted to stay as close to the original colour as possible, but at the same time use an advanced painting system from Standox. The paint was removed from the vehicle body parts, which were then sanded down and protected against corrosion using Standox Etching Adhesion Primer. Beumer's employees used the Standox VOC System Filler to level out any uneven areas on the undercoat before fine-sanding the surface.

The Austin-Healey finally got its elegance back in the spray booth, with a two-tone paint finish in a classic "British Racing Green"-style with the flanks painted in a lighter hue to accentuate them. "We used Standoblue for this", explains Beumer. "Standoblue offers first-class quality and impressive colour depth and vividness". After multiple layers of clearcoat, numerous sanding processes and a high-gloss polish, employees were able to reassemble the vehicle body — and there it was, the 60-year-old vehicle looked as if it was fresh off the production line. The restoration was worth it: The Austin-Healey has been given a second chance at life and is now back in the loving hands of its owner.
